Thermal Sciences

**Shamsher
v.
Omega Flex**

February 15, 2012

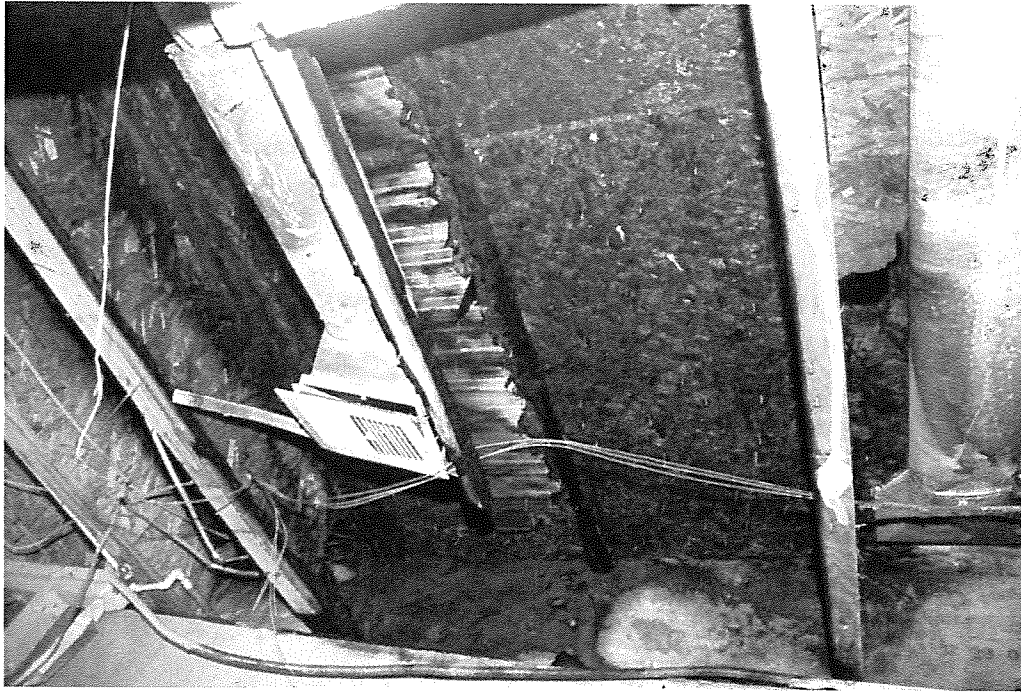
The fire that was identified and extinguished by the fire department was in the basement family room, below the kitchen, between the basement ceiling drywall and 1st floor sub-floor, near the south wall (the family room fire). A hole was found in the TracPipe oven line in the vicinity of the family room fire.

Figure 2. Photograph of the fire damage to the ceiling above the basement family room.⁵

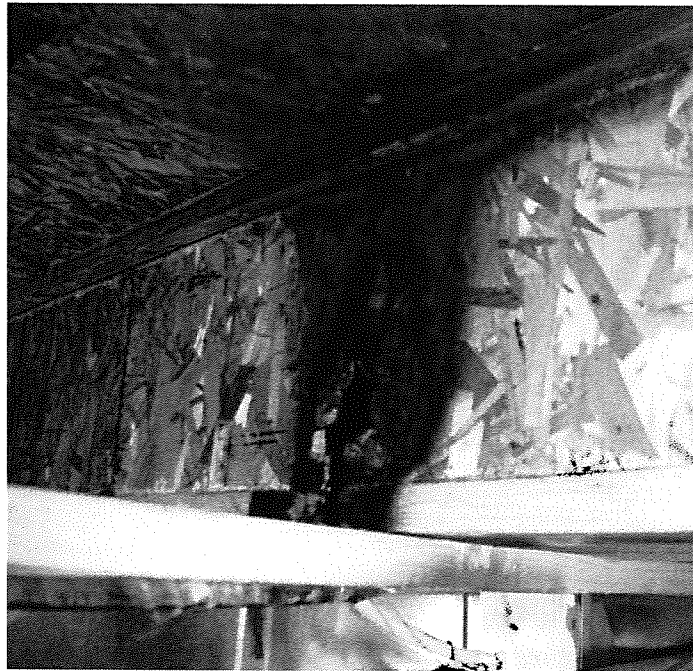
There was also a smaller fire that was not identified by the fire department or by the initial scene inspection performed by Mr. Redsicker. This fire was confined to an area above the ceiling of the basement bedroom near the north wall (the bedroom fire) and was discovered by contractors who were removing drywall in the basement bedroom ceiling. This fire apparently self-extinguished and caused only minimal damage. A hole was found in the TracPipe supply line in the vicinity of the bedroom fire. Photographs of the damage caused by the family room fire and the bedroom fire are shown in Figure 2 and Figure 3. A schematic drawing of the basement, approximate fire locations, and TracPipe lines is shown in Figure 4.

Figure 3. Photograph of the fire damage to the I-joist above the basement bedroom ceiling.⁶

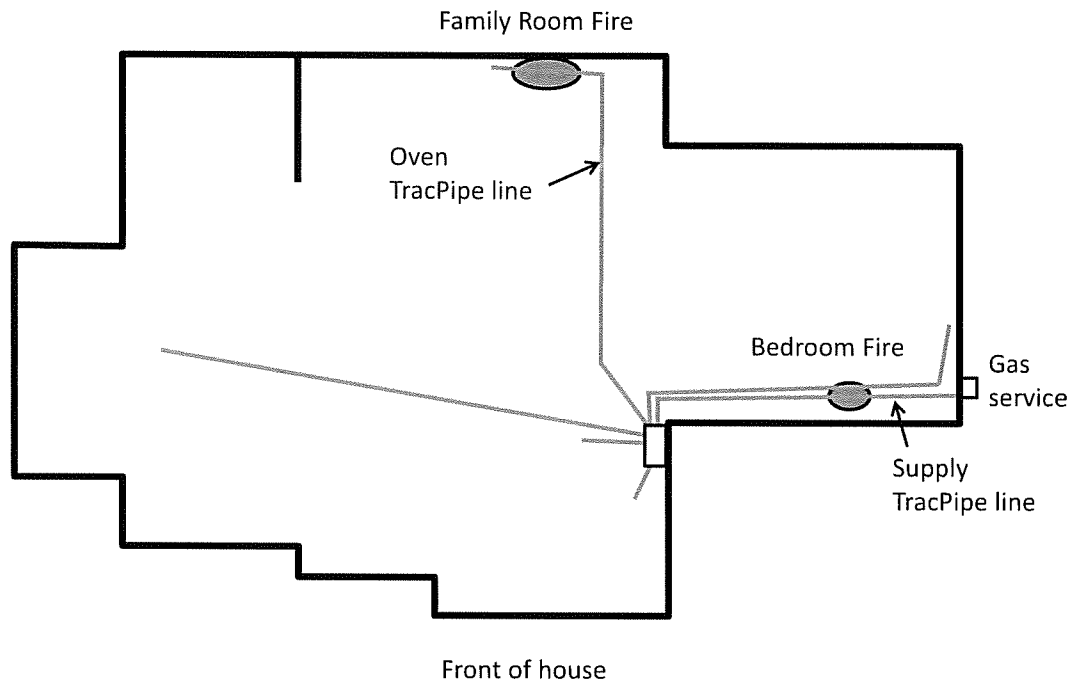
Figure 4. Schematic drawing of the basement of the Shamsheer residence showing the TracPipe lines and approximate locations of fire damage.⁷

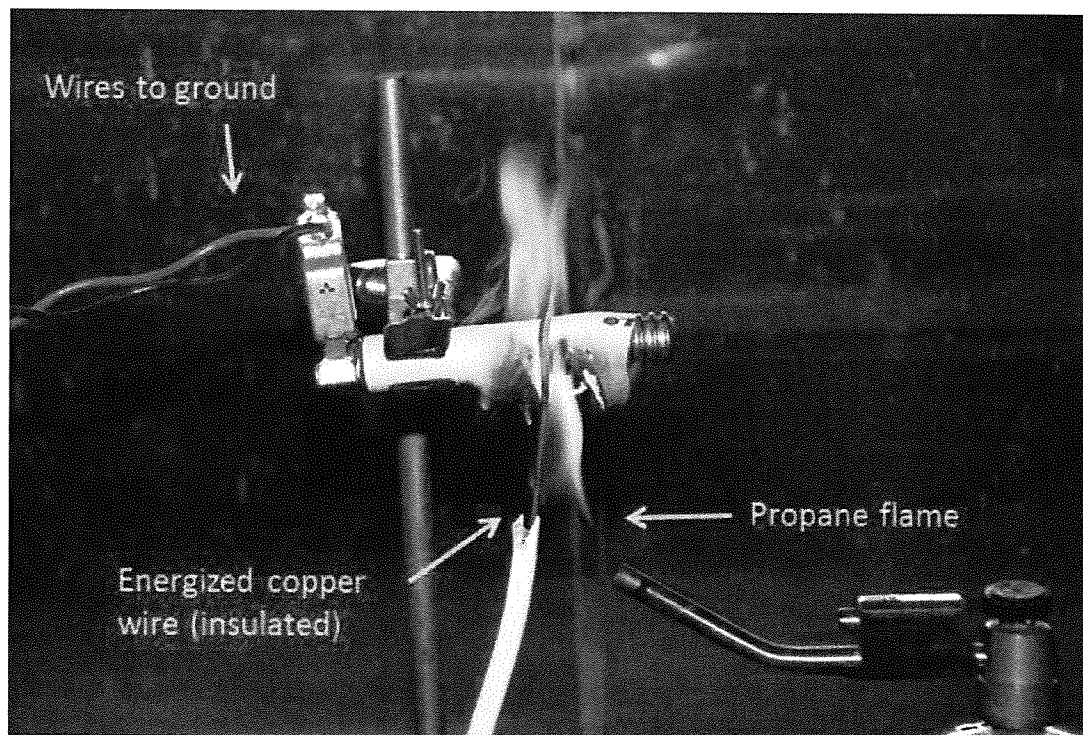
Figure 5. Photograph of the testing of TracPipe in proximity with energized branch circuit wiring in the presence of a flame.

Once the insulation on the conductor and the TracPipe began to burn away, an electrical arc occurred between the conductor and the TracPipe, forming a hole in the TracPipe. An optical microscope image of a hole from such a test is shown in Figure 6. This testing demonstrated that energized electrical wires can cause a hole in TracPipe in the presence of a pre-existing fire. It also allowed Exponent to examine the metallurgical characteristics of such holes. The character of the hole is similar to holes in TracPipe that were allegedly caused by an electrical arc due to lightning. Due to this similarity, it is not possible to identify the source of electrical energy that caused the hole (lightning or household electricity) from an examination of the hole alone.

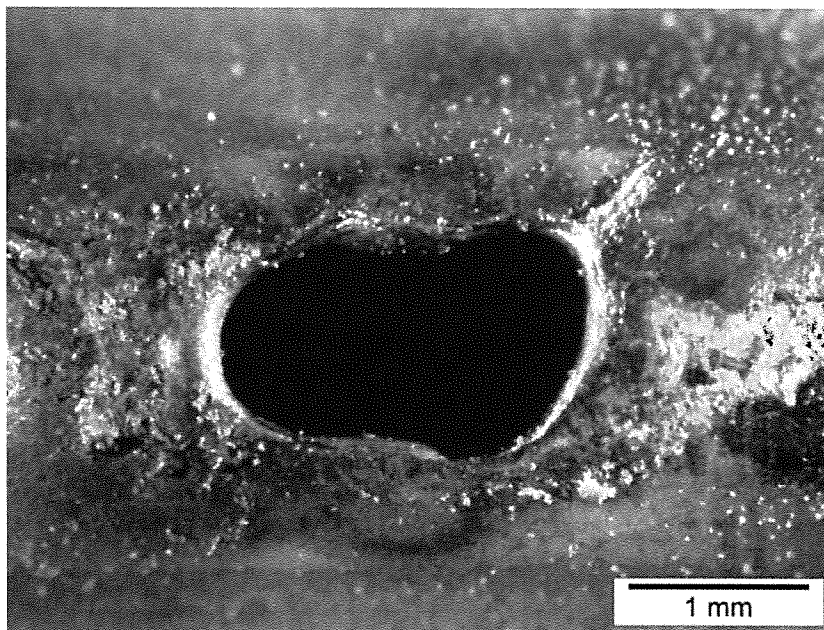
Figure 6. Optical microscope image of hole formed in TracPipe by household electricity in a flame.

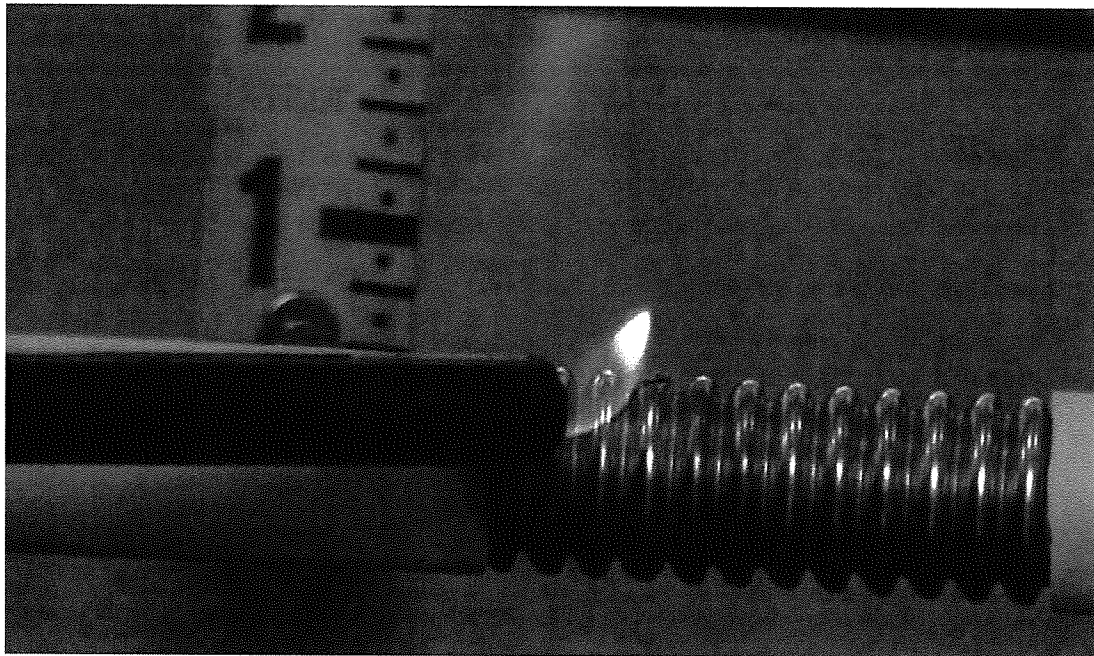
Exponent has performed testing where a butane flame was placed at a hole in TracPipe that was connected to a natural gas supply at a pressure of 7 inches w.c. During such testing, Exponent was unable to ignite the gas. In order to demonstrate that a butane flame was a competent ignition source for natural gas, the flame was then moved a significant distance away from the tubing and the gas was then temporarily ignited. A flame could not be sustained once the butane flame was removed due to blow-off. Photographs from this testing are shown below in Figure 7 and Figure 8. The results of this testing demonstrate that a secondary ignition source, such as nearby burning combustibles, is required in order to ignite gas escaping from TracPipe holes.

Figure 7. Photograph of ignition testing with natural gas and ½" TracPipe. Leaking natural gas could not be ignited at the hole.

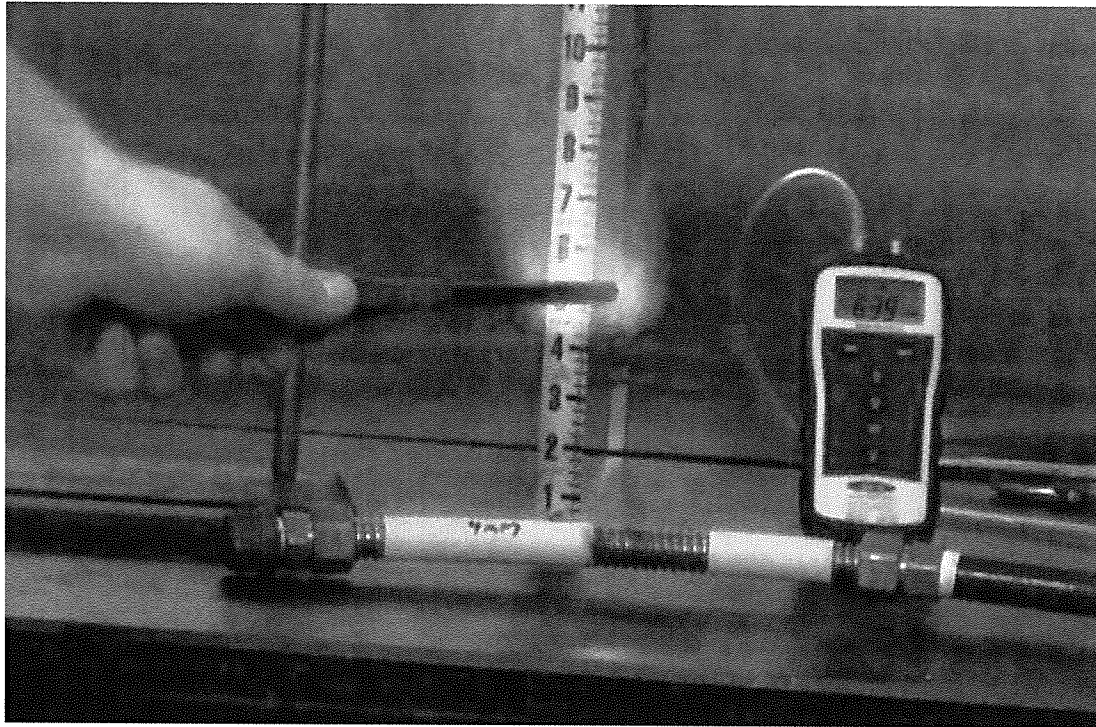
Figure 8. Photograph of ignition testing with natural gas and ½" TracPipe. Ignition of natural gas was possible only some distance away from the hole for a brief duration, but could not be sustained.

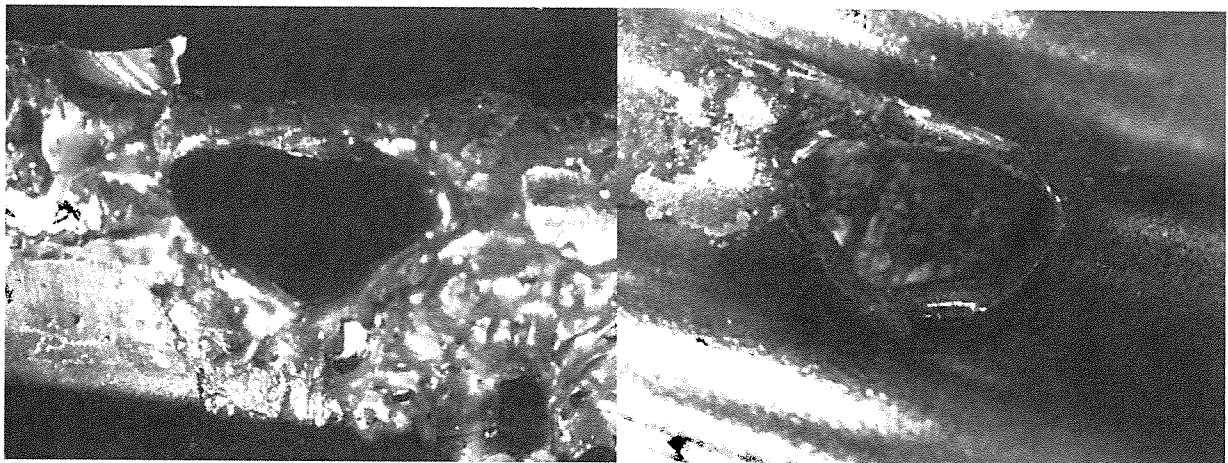
A microscopic inspection of the holes revealed that both holes were likely caused by electrical arcing. The electrical arc locally heated the stainless steel above its melting point causing a hole to form.

In his report, Dr. Eagar states that “the well-defined edges of the hole without the presence of a band of melted metal developing a rounded edge due to surface tension is only consistent with a very short duration arc such as produced by lightning.”²² However, from optical microscope images of the hole in the oven TracPipe line (shown in Figure 9), the hole clearly does have a band of melted metal with a rounded edge. It also looks similar to a hole produced by Exponent using household electricity during testing of TracPipe (see Figure 10). SEM images of the two holes are shown in Figure 11 and Figure 12. The microscopic images of the hole do not allow the determination of the source of electrical arcing that caused the hole. It could have been caused by arcing from an energized branch circuit wire or by arcing induced by lightning.

Figure 9. Optical microscope images taken at MIT of the hole in the oven TracPipe line (family room fire) at the Shamsheer residence. The left image shows the outside of the TracPipe, the right image shows the inside.

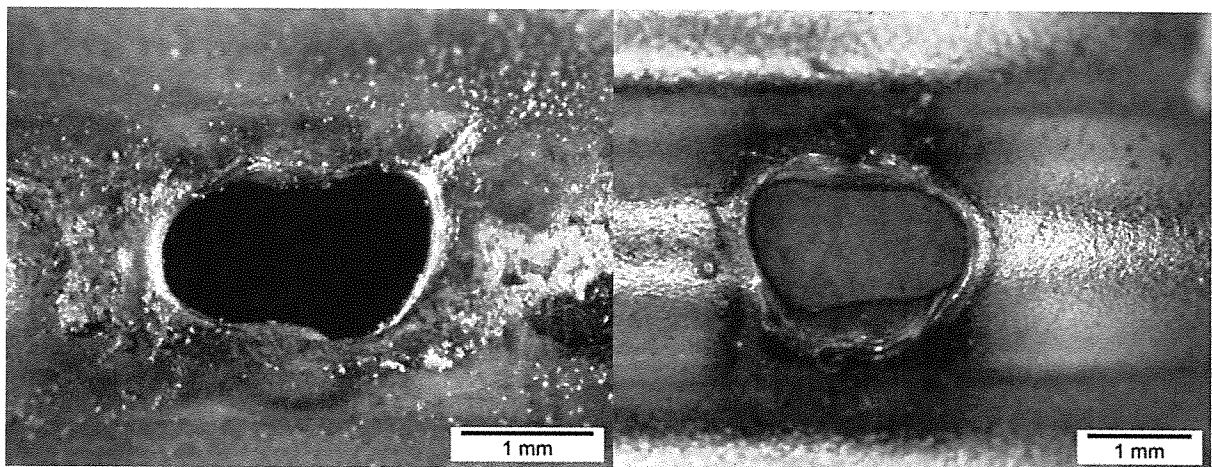
Figure 10. Optical microscope images taken by Exponent of a hole in TracPipe created by arcing with an energized branch circuit wire in the presence of a fire. The left image shows the outside of the TracPipe, the right image shows the inside.

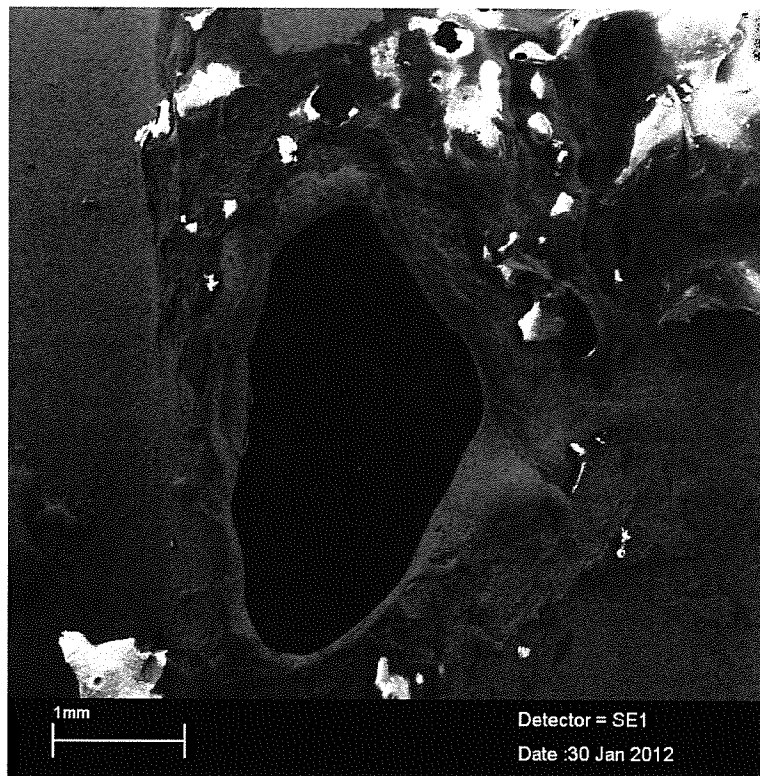
Figure 11. SEM images taken at MIT of the hole in the oven TracPipe line (family room fire) at the Shamsher residence. This image clearly shows the presence of a band of melted metal developing a rounded edge due to surface tension.

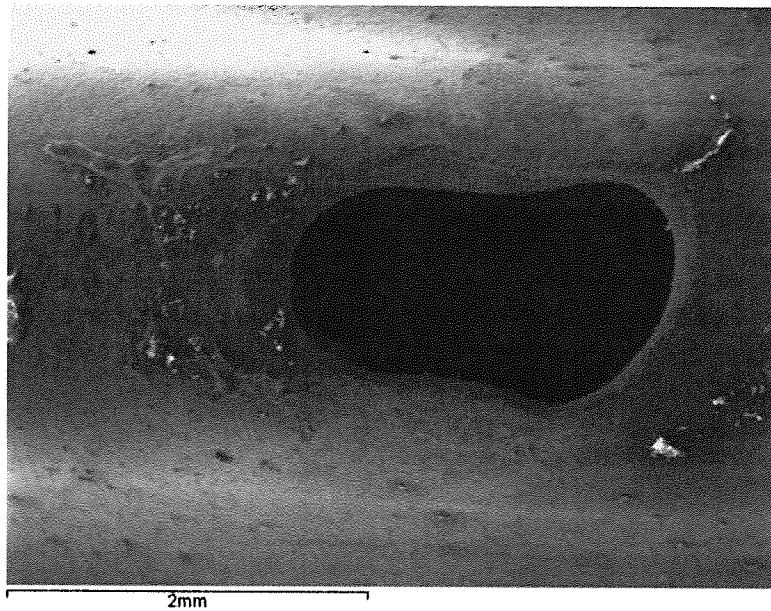
Figure 12. SEM images taken by Exponent of a hole in TracPipe created by arcing with an energized branch circuit wire in the presence of a fire. This is the same hole as shown in Figure 10. This image clearly shows the presence of a band of melted metal developing a rounded edge due to surface tension.

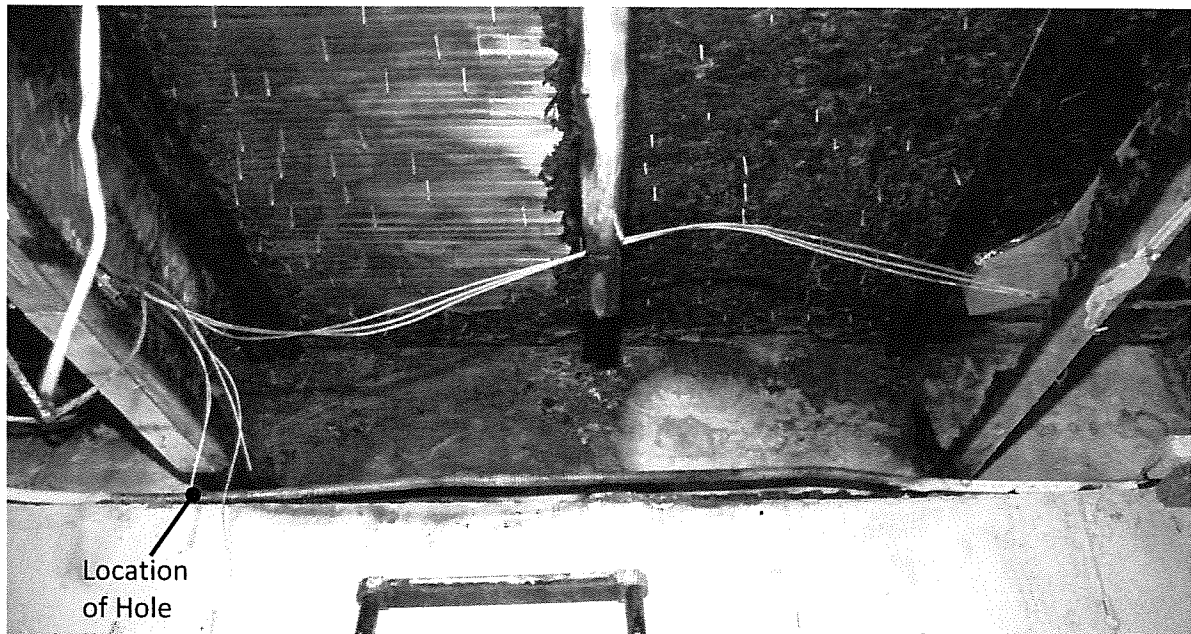
Natural gas leaking from a hole in TracPipe cannot be ignited at the hole as was demonstrated by testing described earlier in this report. Photographs of the area of fire damage show that there is relatively little damage to the I-joist immediately above the hole (indicated in Figure 13). The majority of the fire damage is to the I-joist to the right (west) of the hole, and the subfloor between the I-joist above the hole and the I-joist to the right of the hole (shown in Figure 13 and Figure 14). The natural gas was ignited by an existing fire, at least several inches from the hole, in the space between the I-joist above the hole, and the I-joist to the right.

The only ignition source that could have ignited these combustible materials was an electrical arc caused by lightning. After an initial arc to an energized branch circuit wire, there would have been additional follow-on current. The electrical event that ignited the combustible materials may have also melted a hole in the oven TracPipe line. However, it is also possible that the hole in the TracPipe was formed after the fire started, by an energized branch circuit wire, and that the lightning induced arc that was responsible for igniting the nearby combustible materials did not involve the TracPipe.

Figure 13. Photograph of the area of the family room fire.²³ The oven line TracPipe is visible running across the center of the photograph. The location of the hole found in the TracPipe is labeled.

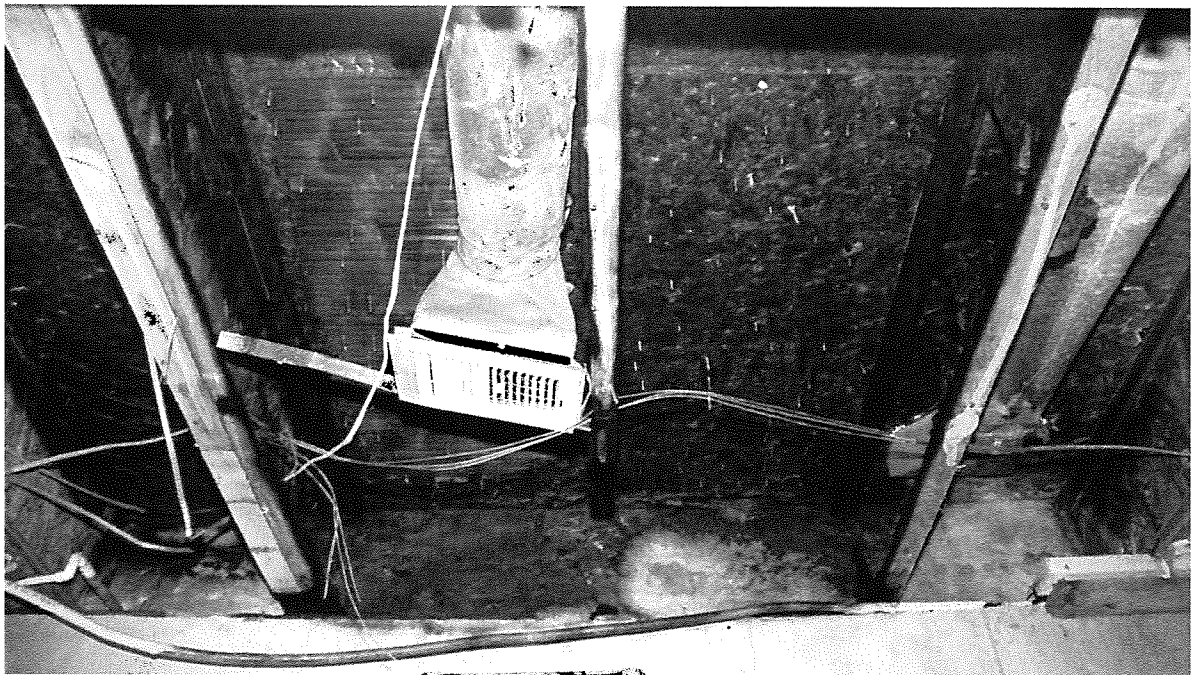
Figure 14. Photograph of the area of the family room fire, with the metal duct visible in the center of the photograph put back into its approximate location before the fire.²⁴

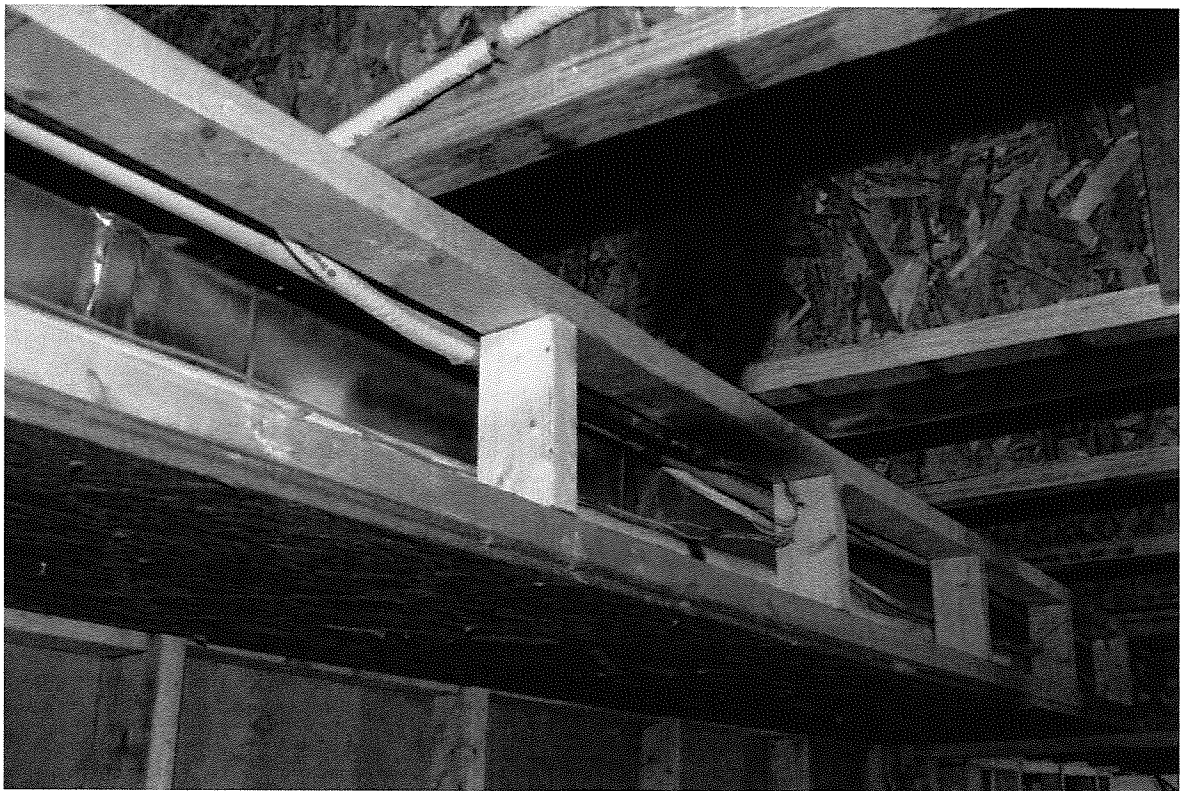
The bedroom fire caused only minimal damage, as shown in Figure 15. A hole was found in the supply TracPipe line in the vicinity of the fire, with evidence of melted metal around the hole, indicating that there was an electrical arc. There were no electrical wires in the vicinity of the hole. The arc most likely occurred between the TracPipe and the metal duct visible in Figure 15. Natural gas leaking from TracPipe cannot be ignited at the hole. Therefore, the first fuel ignited in the bedroom fire was likely dust or wood particles. This small fire then ignited the escaping natural gas some distance from the hole. There was no evidence of ignition sources other than electrical arcing. Therefore, the ignition source was an electrical arc due to lightning. Given the very small amount of damage, it is likely that the leaking gas was only burning for a short time, either because it self-extinguished soon after being ignited, or because it was not ignited until significantly after the initial fire was ignited by the arc.

Figure 15. Photograph of the damage caused by the bedroom fire.²⁵ A metal duct runs across the photograph. Two TracPipe lines run along the duct: the supply line closer to the duct, and the fireplace line farther from the duct. Thermostat wires also run along the duct.
